## A MULTI-SENSOR APPROACH

# Geohazard Management on the Canadian National Railway Corridor

(By Ryan Kromer, Dr Jean Hutchinson, Dr Matt Lato, and Tom Edwards)

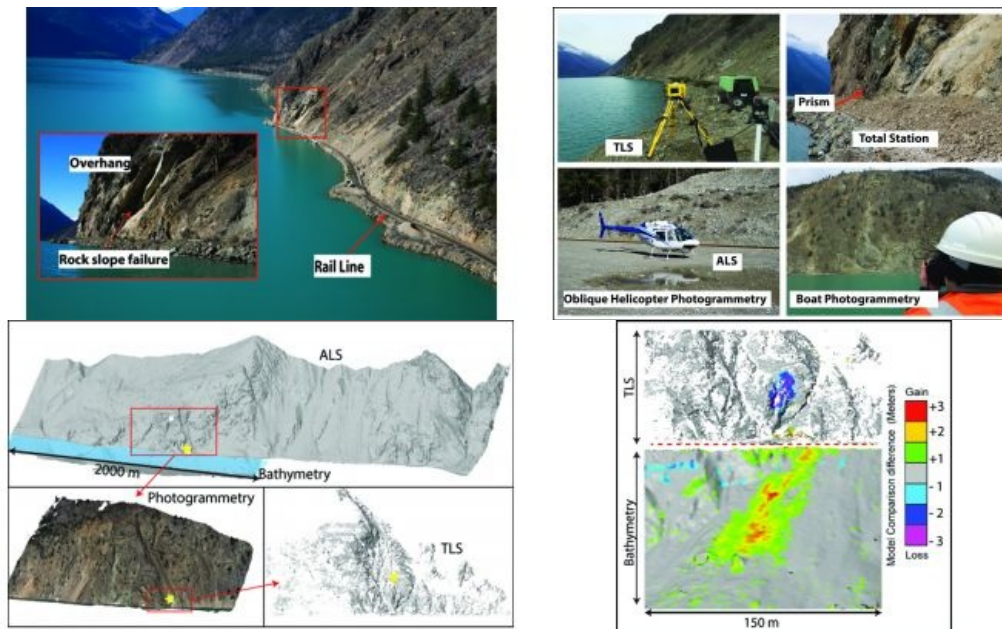
On 9 February 2015, a rockslide occurred along the CN rail line passing Seton Lake between Lillooet and Pemberton, BC. In places the railway follows the shoreline of Seton Lake, adjacent to steep rock cliffs. The run-out of the rock slope failure blocked the tracks and exposed an overhanging, unstable rock wedge. Consequently, the railway line was closed as the risk to railway operations was too high. Initial remediation work consisted of bolting a portion of the unstable rock wedge and scaling of loose material. During this initial work, displacement and cracking of the rock wedge was observed, prompting the collection of 3D data to aid the remediation work and for slope stability assessment. Starting on 23 February, a three-week drill and blast programme was undertaken to remove the unstable rock wedge (Figure 1).

Figure 1, CN railway line at Seton Lake, British Columbia. On 9 February 2015 a rockslide occurred, exposing an overhanging, unstable rock wedge.
