## AVISYSTEM/TAXUS SI

# A Truly Photogrammetric UAV

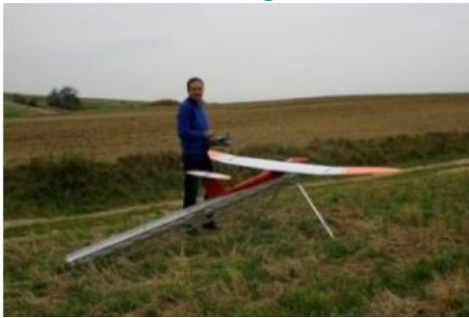
The AviSystem UAV was made on the assumption that it was intended to be a photogrammetric system. Hence, when designing the AVI, it was created for long, stable, precise and efficient flying – photogrammetric flying.

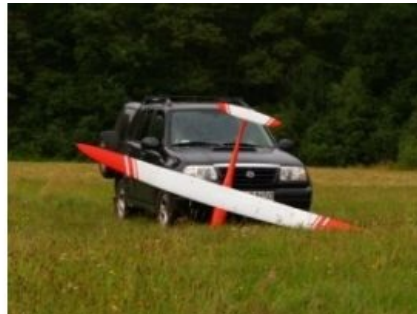
AVI right before take-off.

The AVI is an electrically powered sailplane with a span of 3.5m. The construction is made of carbon fibre which is lightweight, durable and resistant to damage as well as ensuring a high-quality

surface finish. The airframe is very well integrated with the autopilot which precisely retraces flight routes and at the same time controls the photographic module. Two types of non-metric digital cameras are used: a DSLR Canon 550D and SIGMA DP2 compact cameras (one for RGB and the second is modified to capture near infrared), both with fixed
