# Rebuild ready: 3D mapping of a quake-damaged cathedral

After the cathedral of Christchurch, New Zealand, was hit by an earthquake, drones and advanced photogrammetry software supported the rebuilding work.

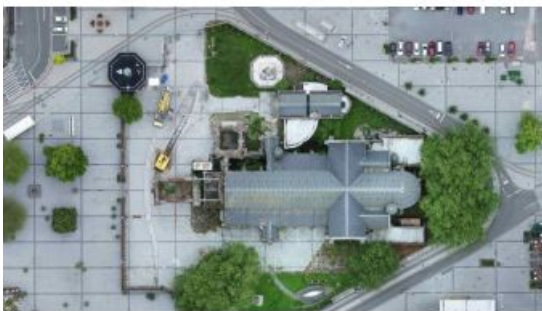
□ 2D orthomosaic of the Christchurch Cathedral in Pix4Dmapper.

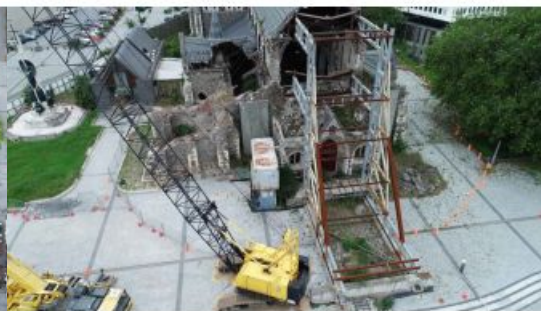
□ The drone flight captured the damaged Cathedral.

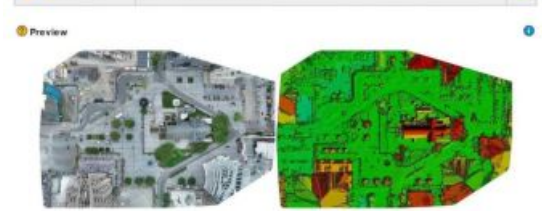
Images	median of 49764 keypoints per image	✓
Dataset	584 out of 584 images calibrated (100%), all images enabled	✓
Camera Optimization	0.1% relative difference between initial and optimized internal camera parameters	✓
Matching	median of 9227 matches per calibrated image	✓
Georeferencing	yes, 6 GCPs (9.30), mean RMSE error = 0.006 m	✓
