ACCURATE AND DETAILED 3D MODELS USING MOBILE LASER SCANNING

Road Maintenance with an MMS

A mobile mapping system (MMS) enables laser data and images of a road and its vicinity to be collected from a van or other moving platform. Here, the author describes data collection and accuracy assessment of a pilot carried out in Finland. It is demonstrated that MMS data processed with sophisticated software is well suited for road maintenance tasks as many parameters can be accurately calculated from the 3D model.

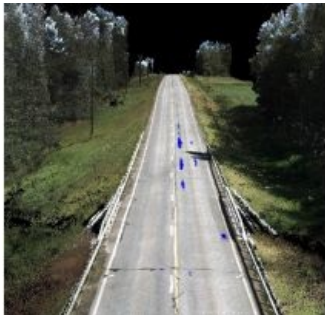
Figure 1, Potholes, ruts and other deformations with a depth of at least 2cm are shown in blue.

After matching the overlap between the forth and back recordings, all non-road points were removed automatically. Orthoimagery with 1cm ground sample distance (GSD) was generated to support detection of road damage and previous repair work (Figure 1). Centre and edge lines and road edges were then digitised manually from the combined laser data and orthoimagery resulting in an accurate vector dataset. The centre and edge lines were used to create a surface model which enabled the extraction from the laser data of ruts and potholes with a depth of at least 2cm. The vertical distance between the heights of inner and outer edges of the pavement (super-elevation) was visualised by across-road arrows and the gradients of the slope (Figure 2). Figure 3 shows seven classes of local slope gradients: red indicates smaller than 1%, orange 1% to 2%, yellow 2% to 3%, yellow-green 3% to 4%, green 4% to 5%, blue-green 5% to 6% and blue larger than 6%. Areas with high gradients will disturb driving conditions but will also have quick water run-off, while the water will remain on flat areas for longer.

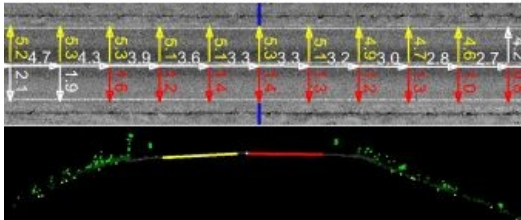
Figure 2, Super-elevation: the blue line marks the location of the road section (bottom)

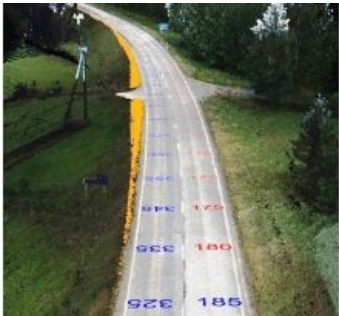
Figure 3, Centre and edge lines are shown in white and local slope gradients shown as classes.
