ROUND-THE-CLOCK OBSERVATION OF A DAMAGED WEIR IN THE NETHERLANDS RESTORES SAFETY WITH CONFIDENCE

Automated Deformation Monitoring Projects for Waterways

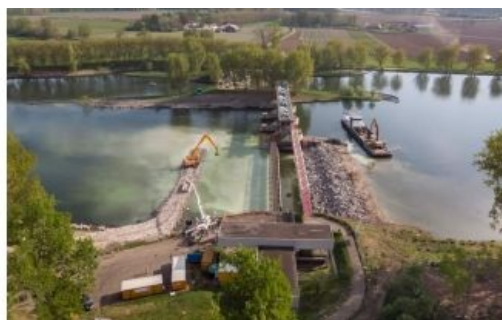
Overview of the project site showing temporary dams both upstream and downstream - work in progress, built to create a dry dock around the damaged weir.
