Dutch 3D Aerial Scanning Project to Reduce Rail Travel Delays

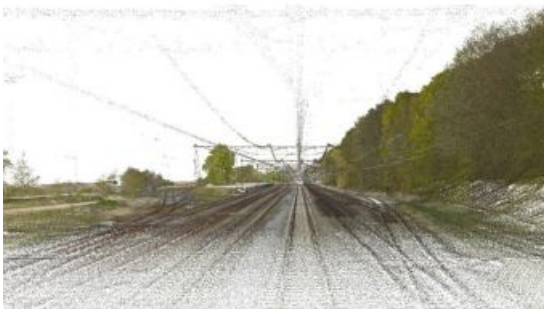
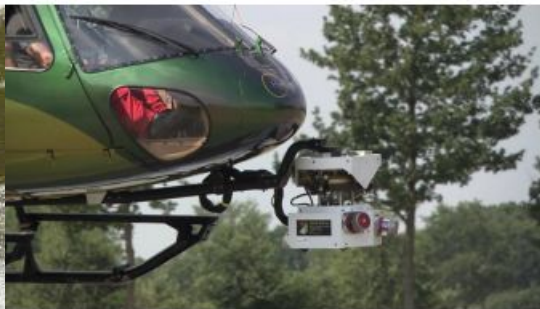
Lidar technology is used to scan railway tracks.

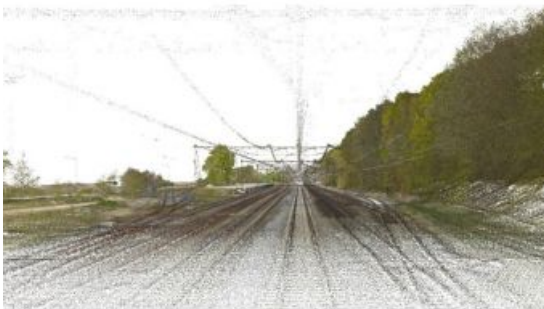
□ Point cloud of a 3D Lidar scan near Ede-Wageningen station.

The 3D images are being captured from the air using a helicopter – fitted with three cameras and two laser scanners – that flies at an altitude of 190m above the tracks. The aerial images are so detailed that signs and the numbers on signal boxes and points are clearly legible. The resulting 3D map will enable maintenance workers to locate and assess issues such as points problems and to initiate a fast response. The map will also be used to boost ProRail's vegetation management and tree-felling programme. The company hopes that this project will reduce delays by 5 to 10% over the next three years.
