"Red mud" Spreads Along the Rivers: New Satellite Images

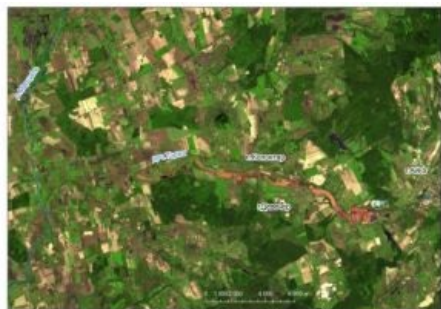
Satellite images enable to access the area of contamination with "red mud" in Hungary. Detailed images of Landsat 5 and SPOT 4, received in ScanEx RDC on October 9-10 by the «UniScan» receiving station in Moscow.

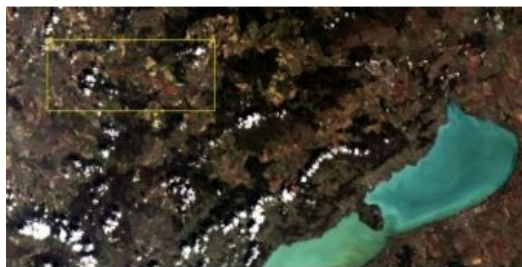
Contamination with "red mud" is clearly seen on satellite images. Landsat 5 image. Acquisition date: October 9, 2010. Data received and processed in ScanEx RDC.

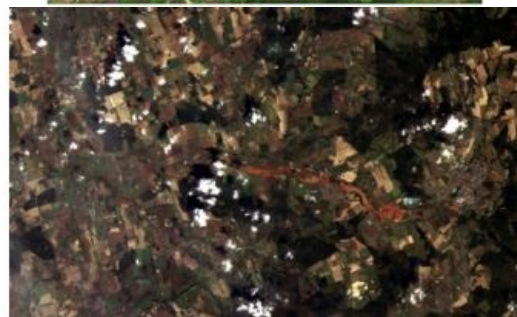
Contamination with "red mud" is clearly seen on satellite images. SPOT 4 image. Acquisition date: October 10, 2010 (SpotImage, SCANEX, 2010).
