# UAS Experiences in Africa: Heat, Dust and Distrustful Locals

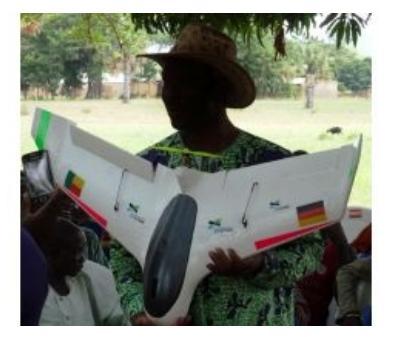
A fixed-wing UAS – wingspan 1.18m – equipped with a 12MP Canon 220-HS camera and a GNSS receiver was chosen to conduct the aerial survey (Figure 2). The weight including camera is 1.2kg and the maximum speed is 90km/h. The battery capacity limits the maximum time in the air to 25 minutes. Surveys are usually conducted with a speed of 50km/h. In other words, during one flight, a 20km-long strip can be captured. In case of loss of signal from the remote control the UAS will navigate autonomously back to the launch site.

Figure 2, An indigenous peasant getting acquainted with the flying object.

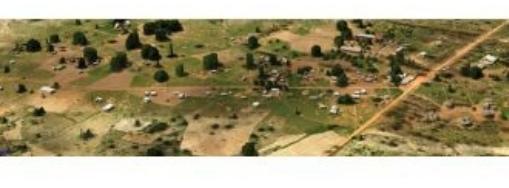
The maximum height difference of the slightly undulating terrain is 50m. The UAS flew autonomously following pre-specified flight paths. GPS initialisation before the start took about one minute. To guarantee safe flights and high-quality positioning, signals from at least six GNSS satellites must be tracked. During this survey an average of 13 GNSS satellites were tracked. One pilot took care of launch and landing (see Figure 3) while a second pilot assisted during the flight. 2,000 images were captured in five flights over the course of three days. For georeferencing purposes, 20 ground control points were established and measured with GNSS. The UAS flew at a height of 250m above ground level resulting in a ground sample distance (GSD) of the true colour images of 2cm. Using Agisoft Photo Scan Professional, a digital surface model (DSM) with a grid spacing of 4cm (although 10cm was requested by the customer) and an orthomosaic were created. By superimposing the orthomosaic on the DSM, a 3D landscape model was created (Figure 4). The vast

Figure 4, Part of the 3D landscape model created from DSM and orthomosaics.
