INSPECTING AND CAPTURING CABLE CAR ROUTES

Conquering Elbrus: mapping Europe's highest peak with a UAV

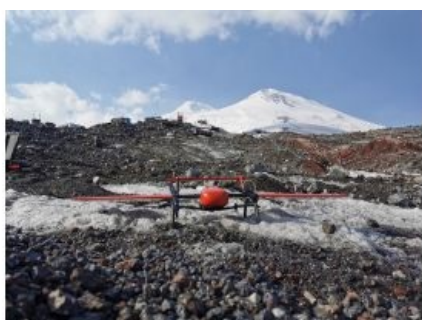
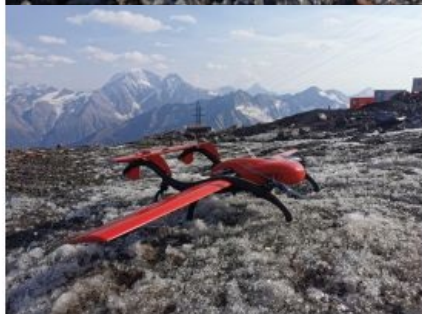
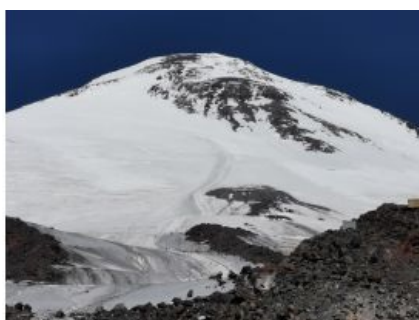
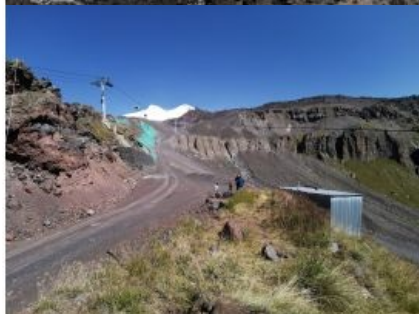
Mount Elbrus.

View of the cable car route and the Mount Elbrus peaks.

Orthomosaic of the mapped area.

The default terrain tracking provided additional safety and precision in the mountainous terrain. As a result, detailed images of the terrain with a total area of 8.2km² were captured with a resolution of 5cm/pixel for a total period of four hours, operating a FIXAR 007 with an onboard equipment weight of 1,000g.

[Metashape software](#) was used for the post-processing to build detailed orthomosaic and 3D models for further area examination and construction evaluation.
