# NASA-produced Damage Maps Aid Mexico Earthquake Response

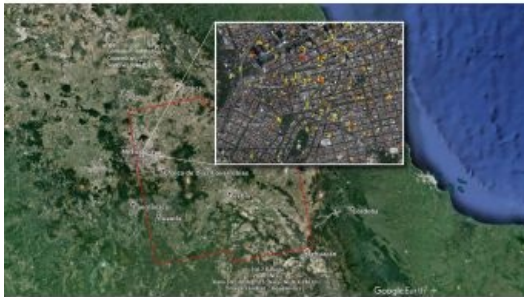
A NASA-produced map of areas likely damaged by the magnitude 7.1 Raboso earthquake near Mexico City on 19 September has been provided to Mexican authorities to help responders and groups supporting the response efforts. The quake, which struck 120 kilometres southeast of Mexico City, caused significant loss of life and property damage.

To assist in the disaster response efforts, scientists at NASA's Jet Propulsion Laboratory and Caltech, both in Pasadena, California, obtained and used before-and-after interferometric synthetic aperture radar (InSAR) satellite imagery of areas of Central Mexico, including Mexico City, affected by the quake, to identify areas of damage and produce what is known as a Damage Proxy Map. The imagery – acquired before the quake on 8 September, and again on 20 September 2017, just 6.5 hours after the

The views indicate the extent of damage caused by the earthquake and subsequent aftershocks, based on changes to the ground surface detected by radar. The colour variations from yellow to red indicate increasingly more significant ground and building surface change. The map should be used as guidance to identify damaged areas, and may be less reliable over vegetated areas. It covers an area of 175 by 170 kilometres. Each pixel measures about 30 metres across.

Preliminary validation of the Raboso quake Damage Proxy Map was done by comparing it to a crowd-sourced Google Map. Sentinel-1 data were accessed through the Copernicus Open Access Hub. The image contains modified Copernicus Sentinel data (2017), processed by ESA and analysed by the NASA-JPL/Caltech ARIA team.
